AFTER
THE TSUNAMI
Rapid Environmental
Assessment

Rapid Environmental Assessment conducted by the UNEP Asian Tsunami Task Force

**AFTER
THE TSUNAMI
Rapid Environmental
Assessment**

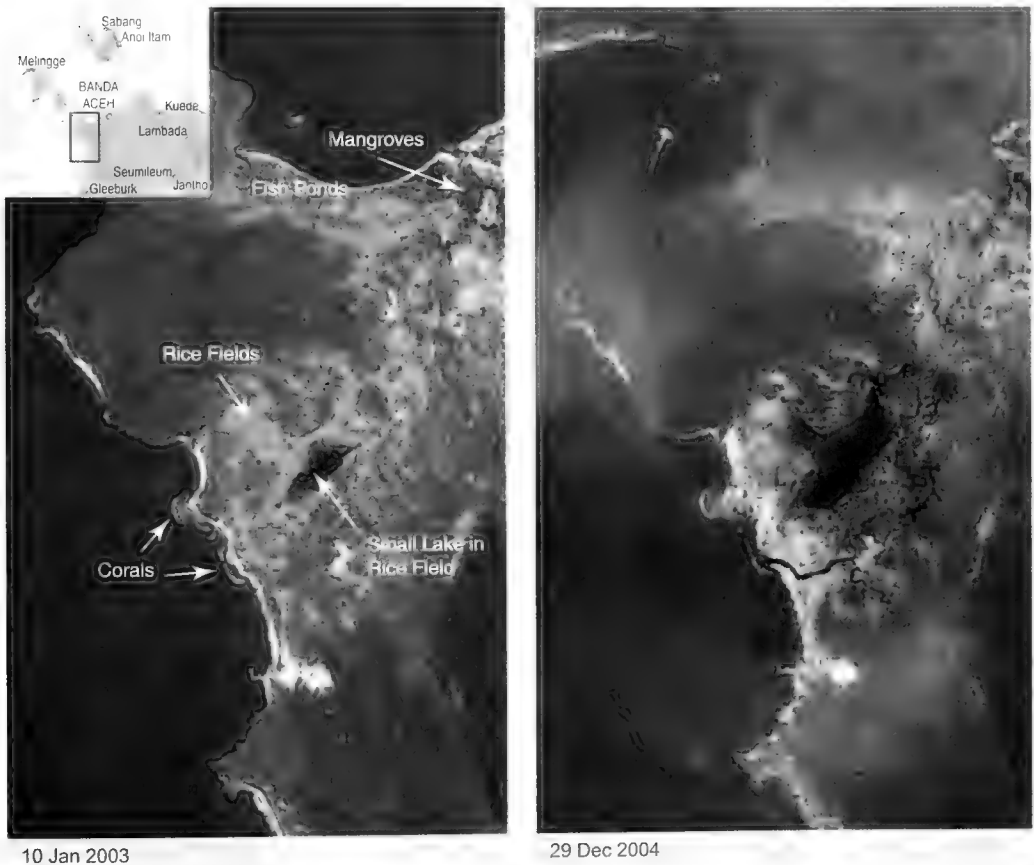
Case study: Overall damage to ecosystems in Sumatra

These images show a combination of a rocky, hilly headland along with a small river delta and swampy coastal strip. A low-lying wetland area connects the northern and western ocean fronts. An integration of natural and agricultural ecosystems operating prior to the tsunami combined rice cultivation, and fish/shrimp ponds (tambak), alongside natural delta mangrove forests and wetlands. Coastal forests and onshore reefs are also present. The effect of the tsunami is clearly evident. It scoured out the low lying delta land, destroyed fish ponds and removed mangrove cover. Volumes of soil and silt have evidently been carried out to sea expanding the area of the small lake by a factor of approximately 10. There has been removal of the sandy beaches (important in some locations for turtle nesting) and deposition of silt or mud on the reef. Apparently minor effects on the integrity of the rocky vegetated shoreline surrounding the headland are likely due to the rocky nature of the substrata, as well as dense natural vegetation cover and the sloping nature of the shore.

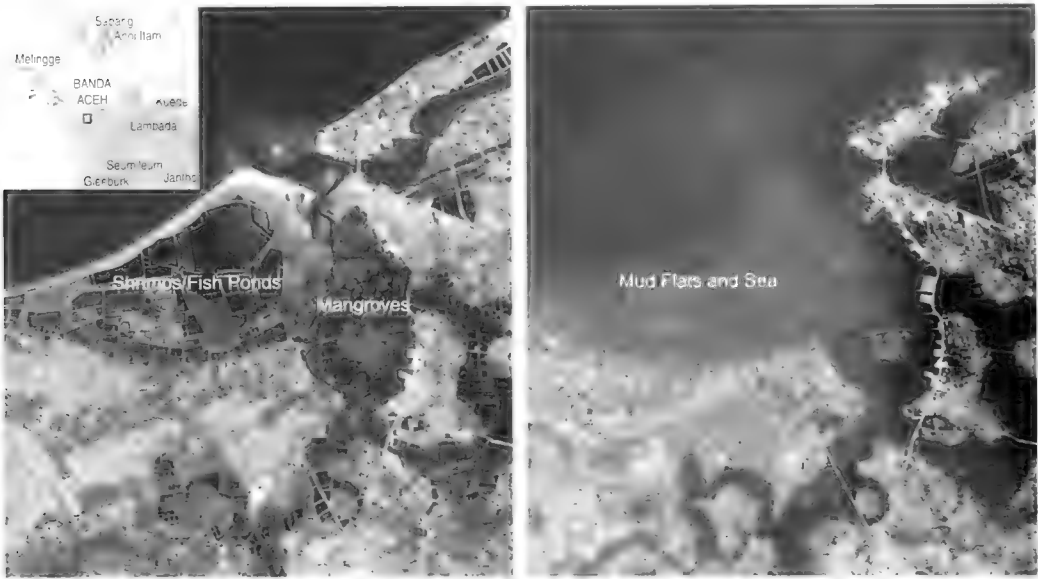
These images show a close-up view of the northern coastal area of case study 1. Features include a swampy coastal strip of land which has largely been converted to tambak. Part of the inland estuary is covered in *Rhizophora* mangroves, which are important spawning and nursery grounds for the milkfish and prawns traditionally raised in the tambak ponds. Further tambak ponds are located inland on the estuarine system. The post-tsunami image shows the devastating effect of the tsunami on the low-lying lands. The force of the water is able to travel up estuarine systems, often up to 6 kilometres inland. The western strip of coastal sandbar has been completely removed and tambak ponds destroyed, along with the majority of the mangroves. Clearly, a vast volume of material was carried out into the ocean. Devastating effects on housing infrastructure are also evident.

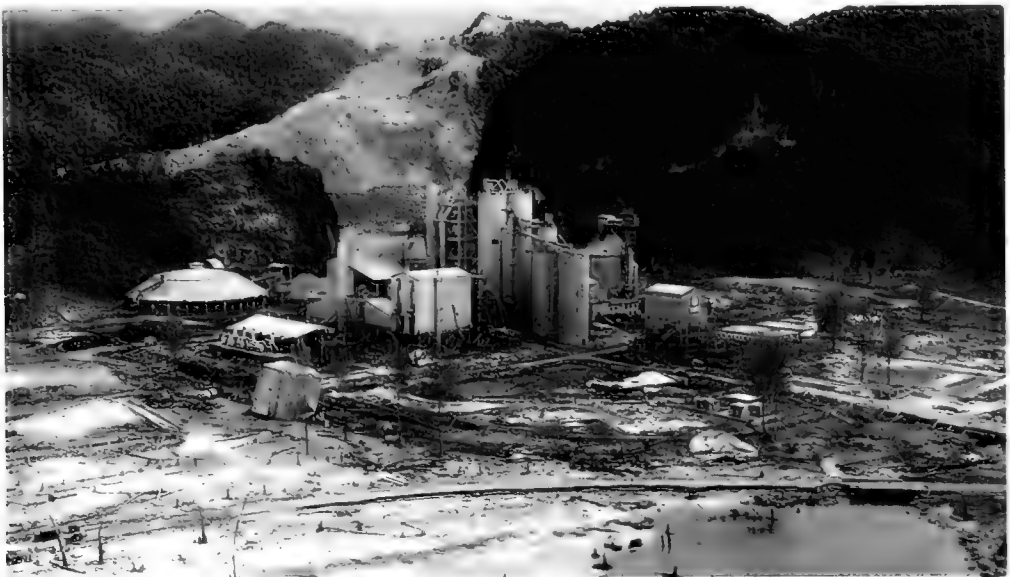
Lhok Nga, Indonesia (5 January 2005). Aerial view of a cement factory at Lhok Nga, south of Banda Aceh, Indonesia. The plant employed more than 600 people before the earthquake. The tsunami damaged an estimated 80 per cent of the facility and killed one-third of the workers. © Reuters/Choo Youn-Kong

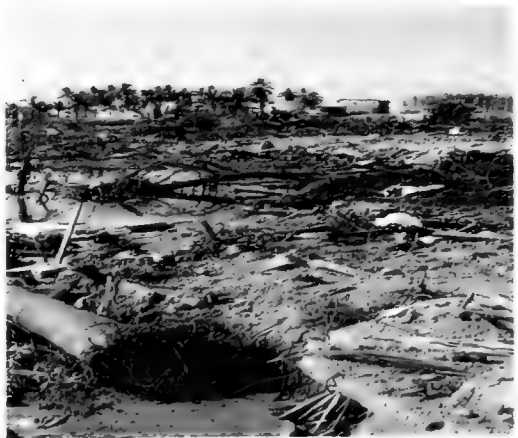
Phang Nga Province, Thailand (January 2005). Coastal area not protected by mangrove forests and severely impacted by the tsunami (location "1" on the map).

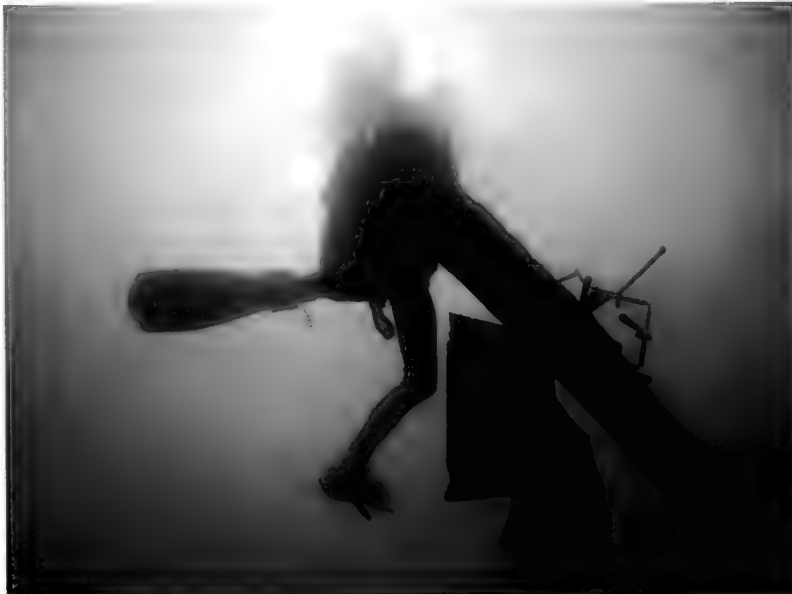
Patong, Phuket Province, Thailand (15 January 2005). As part of the coordinated clean-up operations, large and small debris being lifted to the surface to prevent further damage to the coral reefs. © Department of Marine and Coastal Resources, Ministry of Natural Resources and Environment.

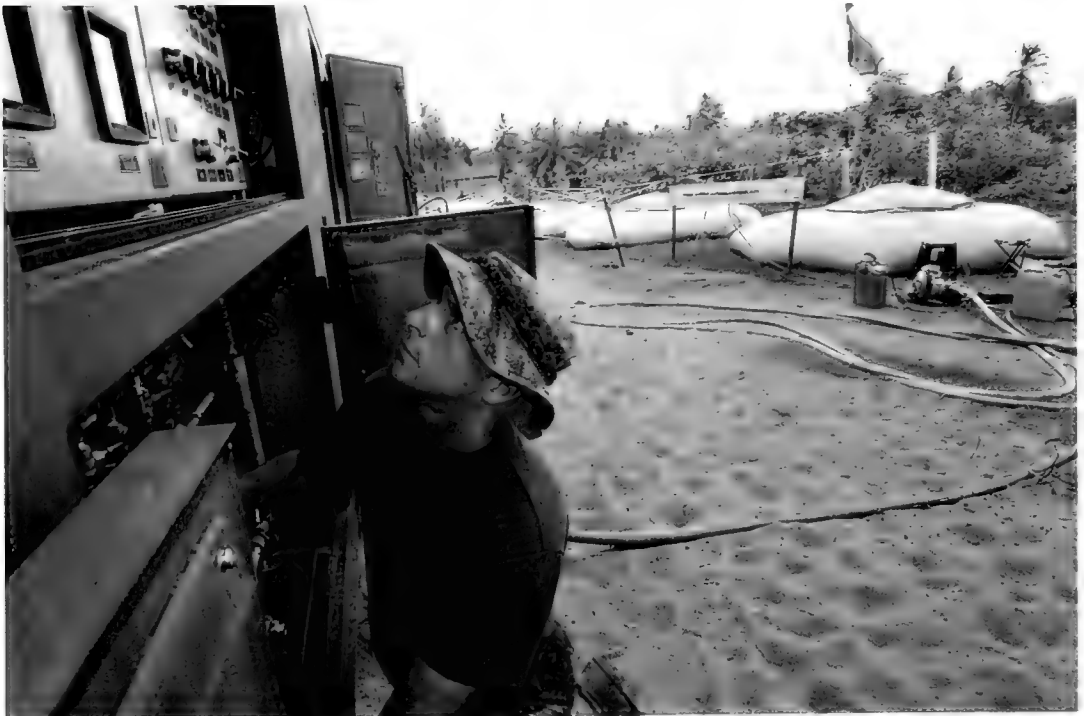
Kalmunai, Sri Lanka (3 February 2005). Checking the water purification machine in Sri Lanka's eastern town of Kalmunai. A 200-member Canadian military contingent is conducting relief operations on the east coast, providing clean drinking water for 80,000 tsunami survivors. © Prakash Singh/AFP/Getty Images

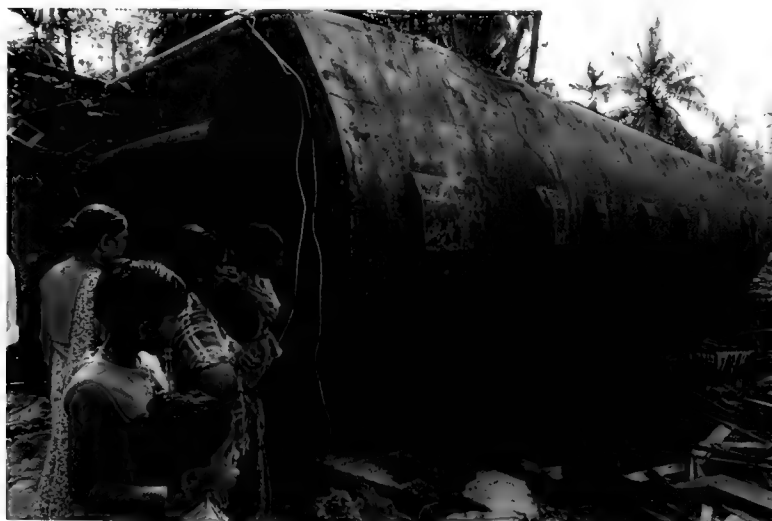
Hikkaduwa, Sri Lanka. The 26 December tsunami overwhelmed a passenger train in southern Sri Lanka, killing some 1,500 passengers. Over half are now enduring significant hardship due to the absence of rail services in the southern corridor, which are not expected to be restored before May 2005. © Shehzad Noorani/Still Pictures

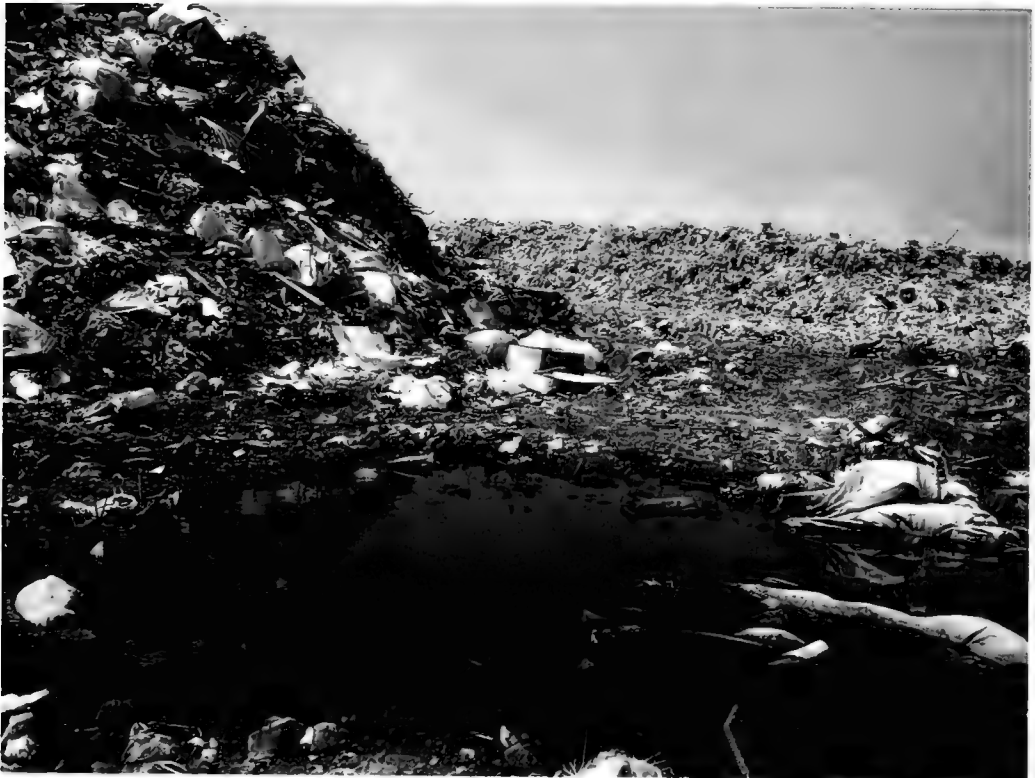
UNEP investigations of tsunami-affected islands consistently found solid waste dispersed over entire islands. Tsunami-related debris contains a mixture of demolition waste, household waste from former dumpsites, vegetation, metals, animal remains and hazardous compounds. Of particular concern is the presence of asbestos from roof sheeting. Initial clean-up operations have frequently worsened conditions by piling debris on the beaches, where it either washes off or threatens groundwater. UNEP has worked with the Maldives MEC to provide disaster waste guidance and waste management workshops and to commence an emergency asbestos management programme.
